CHLORINATED SOLVENTS IN A COMPLEX MATRIX: AGREED PLAN OF MANAGEMENT, WITH NATURAL ATTENUATION, AFTER *IN SITU* REMEDIATION

Laurent THANNBERGER

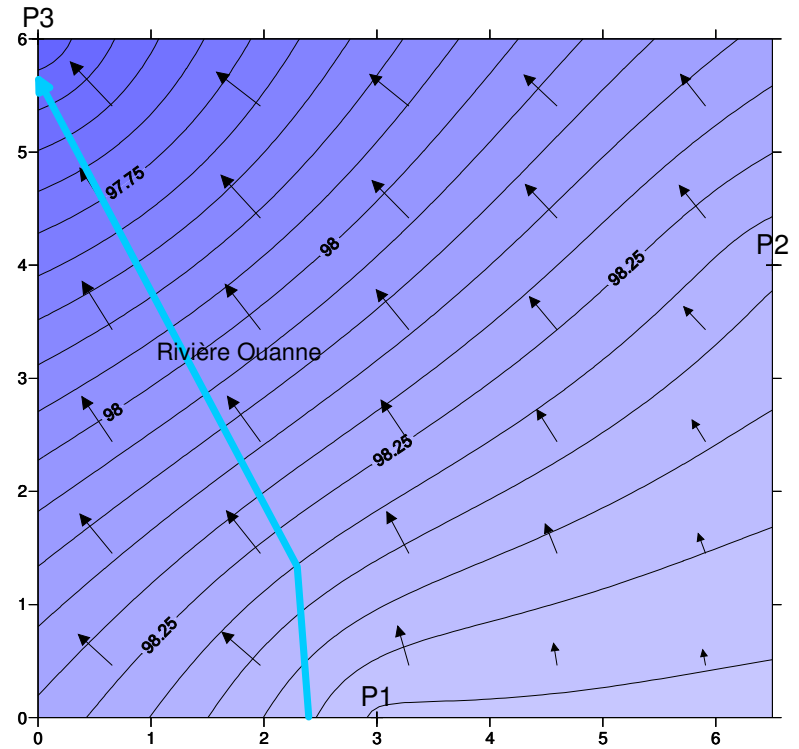
River's aquifer modelling

- First investigations, in 2004, found 2 pollution sources:
 - The TPH source was purged out
 - The PCE source (5,5 mg/kg) was kept in place (P2)
 - HVOC were the major contaminants in groundwater
 - The whole degradation panel of chlorinated compounds was found: PCE (up to 91,2 mg/L in P1), TCE (up to 23 mg/L), cis-1,2-dichloroethylene (20,2 mg/L) and vinyl chloride (up to 0,68 mg/l).
- Later investigations, after site's closure, showed that plumes migrate, following groundwater major stream, with the risk of impacting a potable well 2.5 km downstream

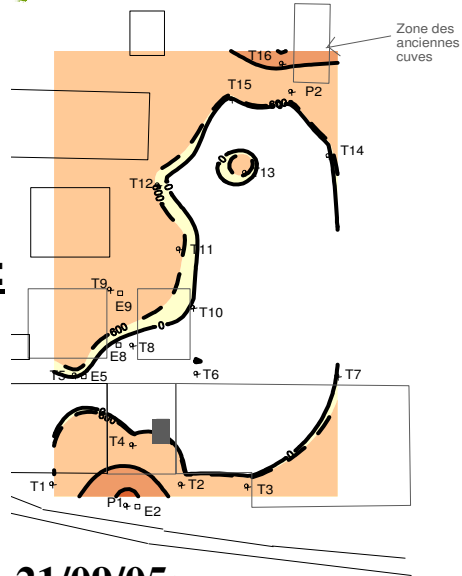
21/09/05:

PCE contamination:

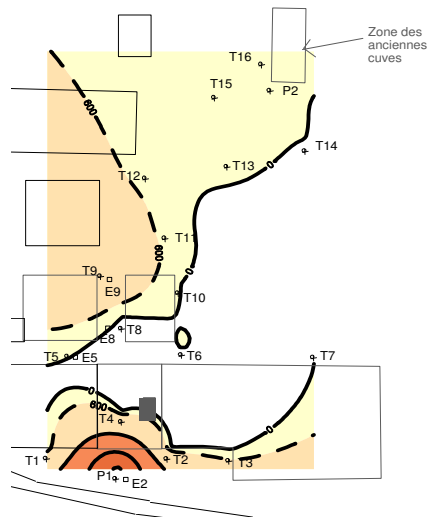
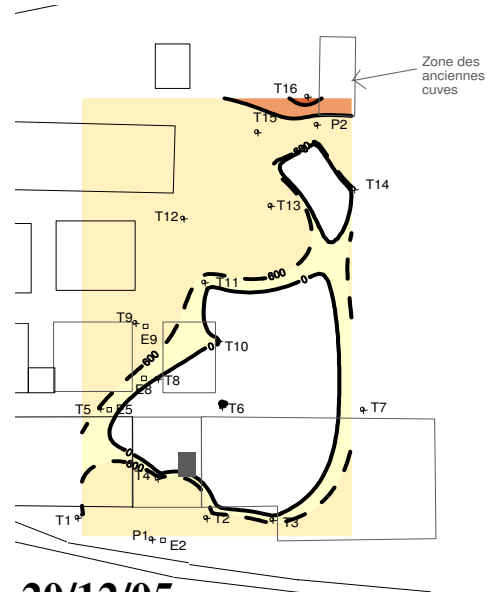
TCE contamination:

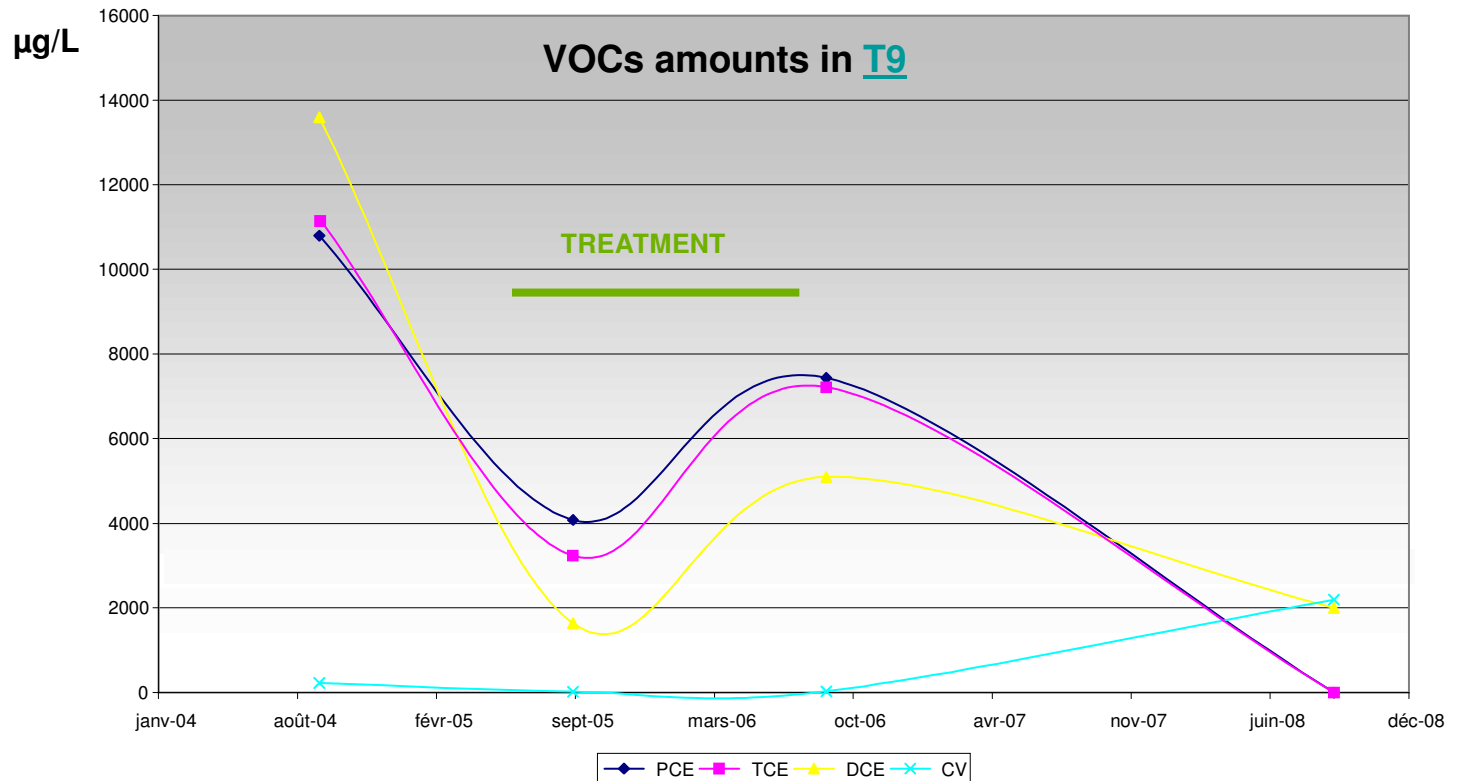
- Last measurements showed drastic breakdowns in VOCs amounts since the treatment stopped
- Beside the decay of highly chlorinated molecules, degradation products are rising (CV, Cl-).

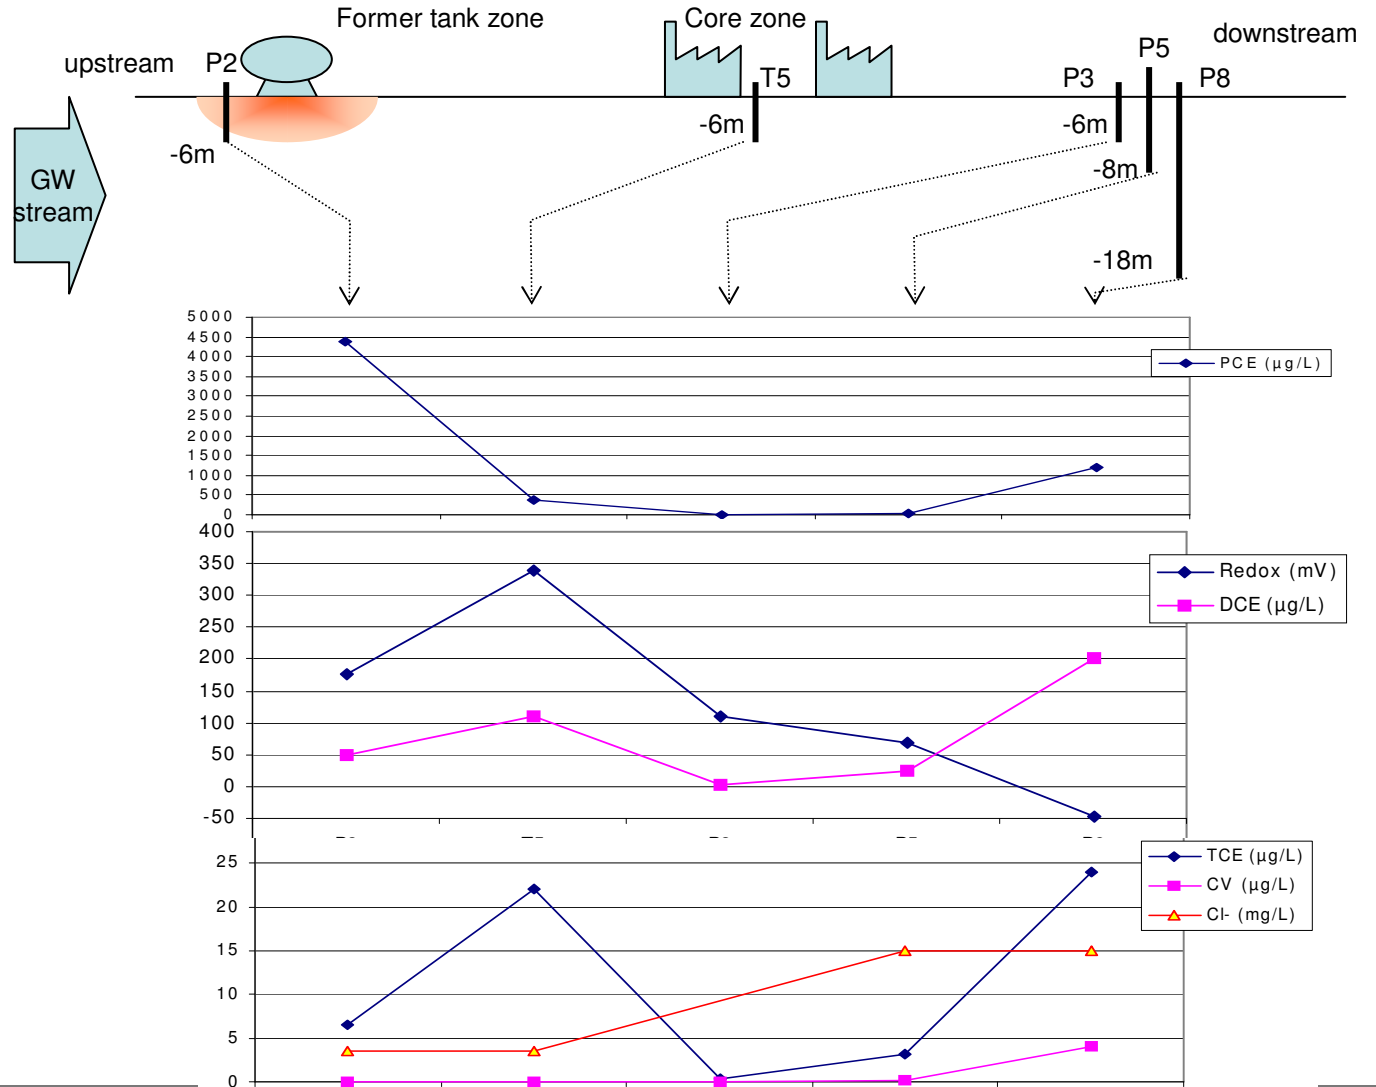
Measures: in situ, the 21/08/08

Furthermore, several hints demonstrate the effectiveness of biodegradation, as presented to the DRIRE (2008):

- Significant decrease of whole contamination since activity stopped (from an average of 80 to 2 mg/L)
- low pollutant mass export (g/d, based on groundwater speed and thickness)
- Evidence of biodegradation mechanisms, aerobic (peripheral zone), as anaerobic (deep and core zone)

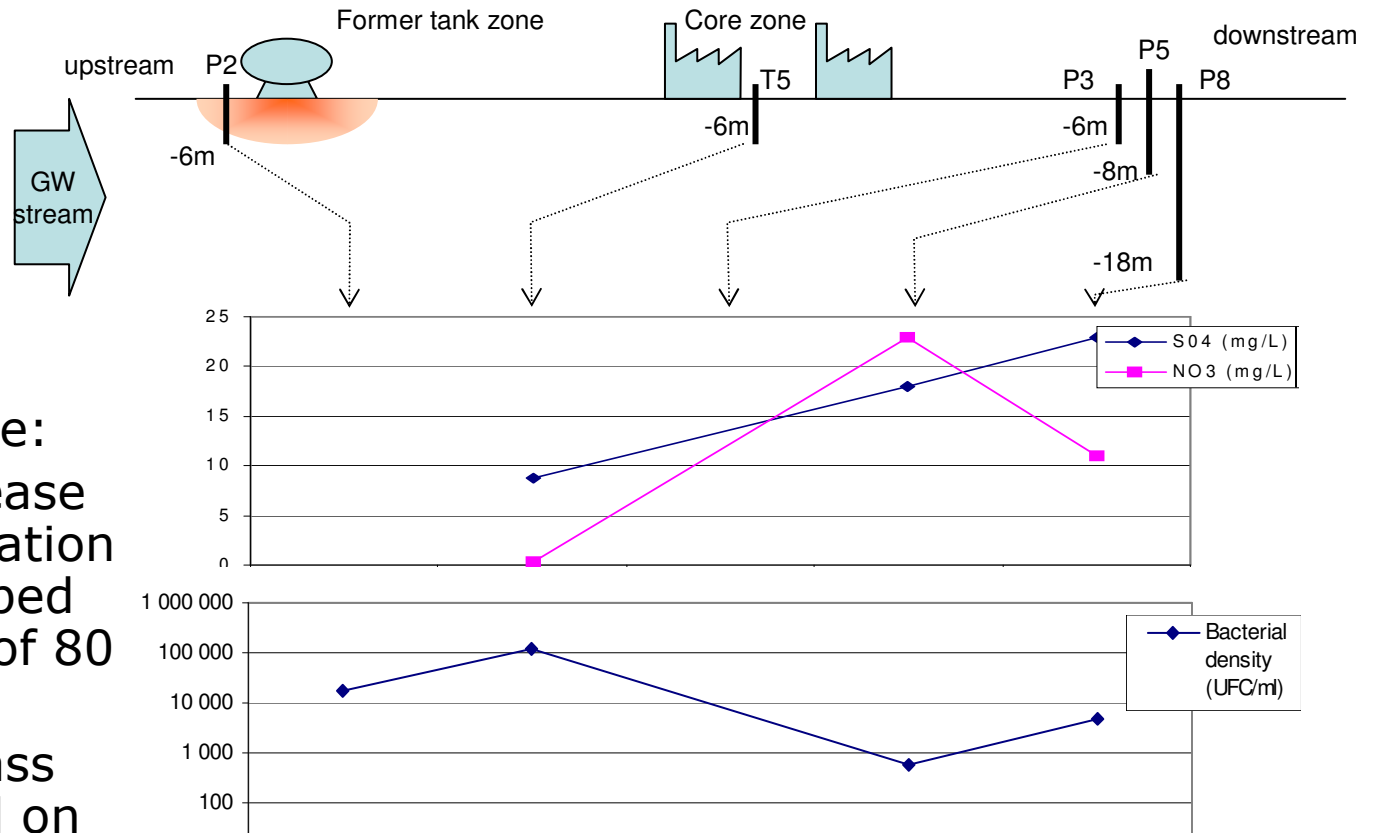
Measures: in situ, the 21/08/08

Data compilation allowed to conclude:
